Flightfax

ARMY AVIATION
RISK-MANAGEMENT
INFORMATION

June 2001 ♦ VOL 29 ♦ NO 6

Over water missions—
Ready or Not

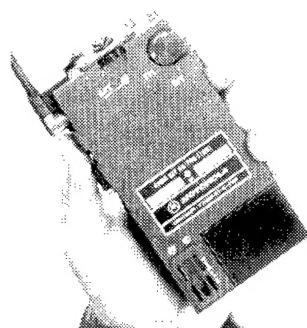
The AN/PRC-112 Survival Radio has three identified issues which may contribute to a degradation of the radio's operational readiness for the soldier in the field.

1. The large VOL/OFF knob can accidentally be turned on when the radio is handled. If turned on, it will lead to a dead battery.
2. Water has been reported to leak into the radio's case, rendering the radio inoperable.
3. Chance frequency hopping due to the design of the radio's transponder may yield less reliable communications.

There is an upgrade program for the AN/PRC-112 currently underway which addresses each of these issues:

1. The current VOL/OFF knob is replaced with a smaller knob that is more difficult to accidentally turn on.
2. A new, better gasket that stops the water

intrusion is installed.

3. A more efficient transponder is installed that corrects chance frequency hopping.
